## ENGINEERING PROJECTS:PROGRESS REPORT

### Hurricane Matthew Recovery Project

- Project: Cross Creek Bank Stabilization
- Status: Under Construction
- Creek bank damaged by Hurricanes Matthew in 16 and Florence in 2018
- Timeline: May 2021  
Anticipated Project Completion
- Budget: \$7.6M

## Cross Creek Bank Stabilization at Lamon Street

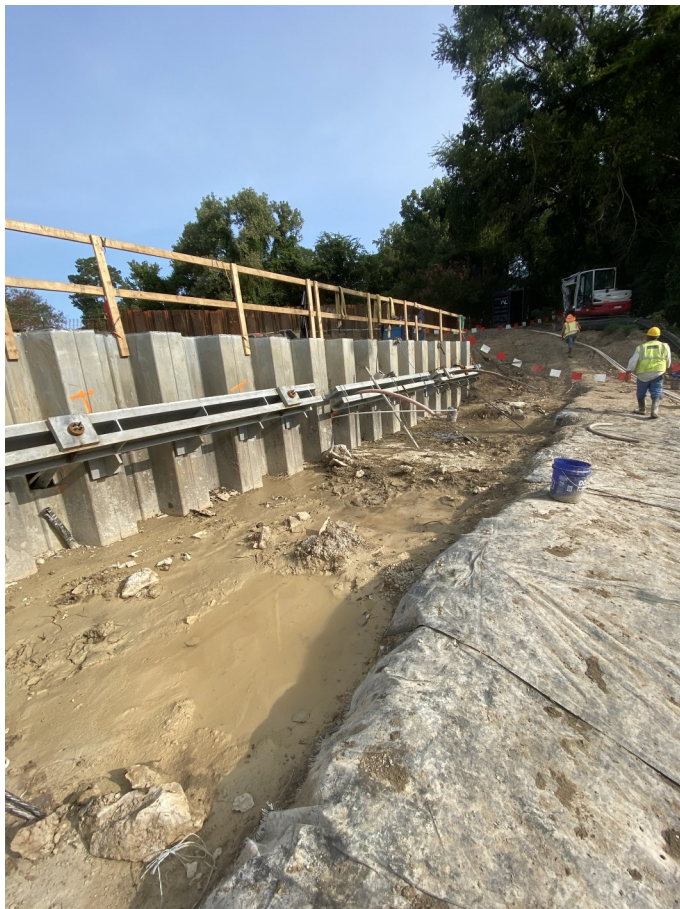
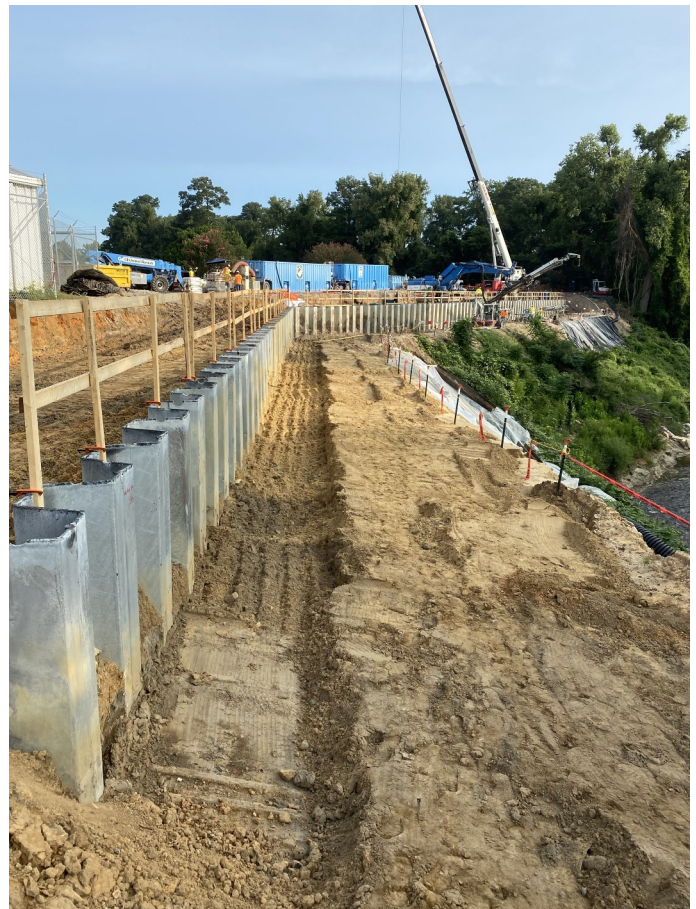
This week the contractor installed and tested cables and installed whalers. The contractor maintained erosion control and removed brush on opposite bank in preparation for stream restoration.

**Current Status:** Current Status: Hurricane Matthew damaged the bank of Cross Creek near 280 Lamon Street on October 8, 2016. The left bank was eroded near the City's Parks and Recreation administration building and washed away a portion of Linear Park Trail. Bank erosion was worsened by Hurricane Florence in September of 2018 and extended further downstream, encroaching into Cross Creek Cemetery.
